## Document details Cornell waste spill

### Overflow ran at least 14 hours, letter shows

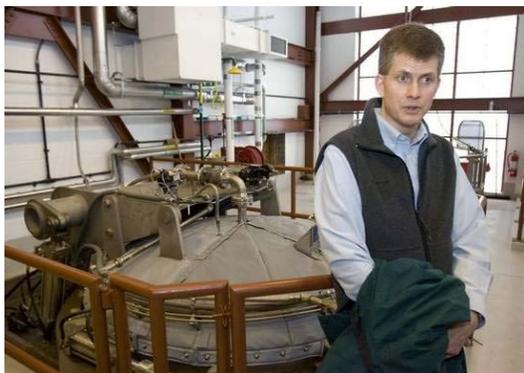
Cornell University Biosafety Engineer Paul Jennette talks about the operation of the alkaline hydrolysis digester, lower left, which is in the final stages of testing in the College of Veterinary Medicine's new Waste Management Facility. The digester works by combining extreme heat, pressure and chemical digestion to dissolve animal carcasses. (SIMON WHEELER / Staff Photo)

The digester combines extreme heat and pressure with chemical digestion to dissolve animal carcasses into two components: a liquid, known as hydrolysate and sterilized bone fragments.

The manufacturer has corrected the error and modified the program to add safety checks, according to a statement from Cornell. The feature that allowed the digester to drain and fill automatically has been removed. Those functions will no longer happen without action by an on-site operator, the statement read.

In addition, the digester's air vent outlet will be rerouted to a containment area so that overflow can no longer directly enter the storm or sanitary sewer systems.
